**Flood Control Project Maintenance
Levee Inspections**

Fall 2015 Levee Maintenance Deficiency Summary Report

Sutter Maintenance Yard Maintenance Area 0013

Waterway			Bank	Unit Miles
Unit No. 01 Cherokee Canal			Right	18.19
	Spring (March - May)	Summer (June - August)	(September - November) Fall	Winter (December - February)
Unit Maintenance Rating (Fall Only)			A	
Date of Inspection	05/06/2015 - 05/06/2015		11/06/2015 - 11/06/2015	
DWR Inspector	Bob Duffey		Bob Duffey	
Accompanied By	Shawn Freitag Sutter Maintenance Yard		Shawn Freitag Sutter Maintenance Yard

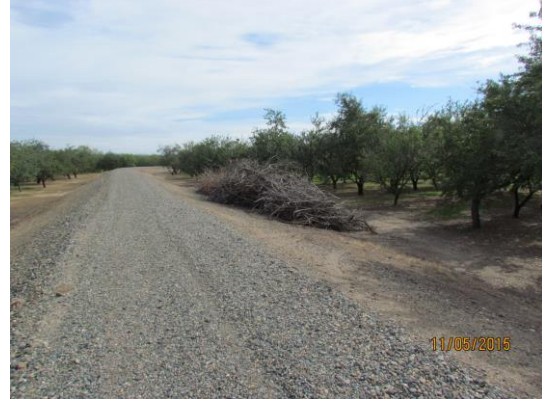
Photo 1 of 1 : FA_2015_MA0013_300_43_20151109_00014.jpg

LM Start	0.45	Rating **	M	Issue No.	43
LM End	0.45	Issue Type +	En	Location *	LS
Category	Earthen Levee			GPS Latitude/Longitude	
				Start	End
Item	Encroachments			39.591237 °	39.591237 °
				-121.702015 °	-121.702015 °
DWR ID	DWR_MA0013_01_f_2015_43				
Action/Comments					
Prunings					
Inspector Comments: Remove the prunings from the landside slope.

View of the prunings along the landside slope.

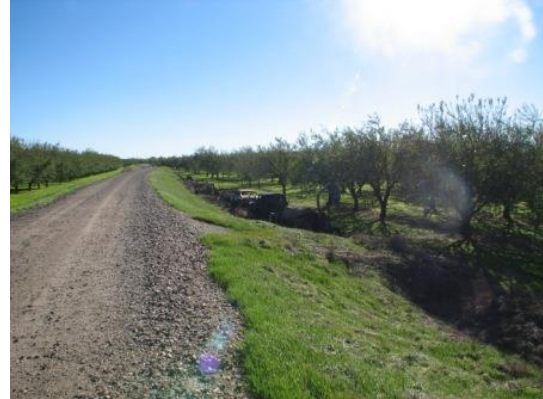
Photo 1 of 1 : FA_2015_MA0013_300_12_20150910_00006.jpg

LM Start	0.73	Rating **	M	Issue No.	12
LM End	0.76	Issue Type +	En	Location *	LS
Category	Earthen Levee			GPS Latitude/Longitude	
				Start	End
Item	Encroachments			39.587905 °	39.587505 °
				-121.700822 °	-121.700880 °
DWR ID	DWR_MA0013_01_s_2012_12				
Action/Comments					
Equipment					
Inspector Comments: Remove the equipment from the landside toe.

View of the equipment along the landside toe of the levee.

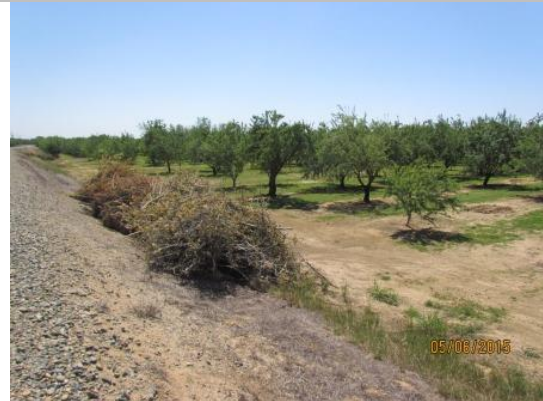
Photo 1 of 1 : FA_2015_MA0013_300_44_20150910_00011.jpg

LM Start	0.87	Rating **	M	Issue No.	44
LM End	0.87	Issue Type +	En	Location *	LS
Category	Earthen Levee			GPS Latitude/Longitude	
				Start	End
Item	Encroachments			39.585857 °	39.585857 °
				-121.700540 °	-121.700540 °
DWR ID	DWR_MA0013_01_s_2015_44				
Action/Comments					
Prunings					
Inspector Comments: Remove the prunings from the landside slope.

View of the prunings along the landside slope.

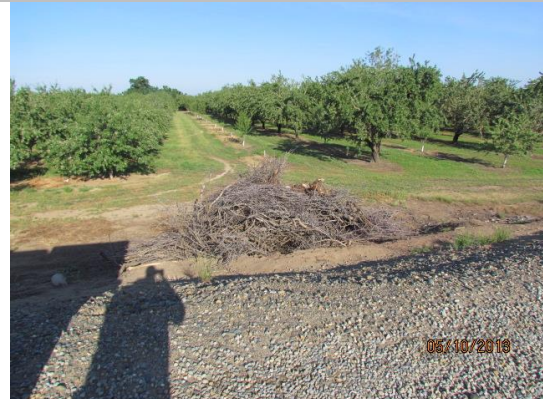
Photo 1 of 1 : FA_2015_MA0013_300_20_20150910_00010.jpg

LM Start	0.94	Rating **	M	Issue No.	20
LM End	0.94	Issue Type +	En	Location *	LS
Category	Earthen Levee			GPS Latitude/Longitude	
				Start	End
Item	Encroachments			39.584885 °	39.584885 °
				-121.700487 °	-121.700487 °
DWR ID	DWR_MA0013_01_s_2013_20				
Action/Comments					
Prunings

View of the prunings along the landside toe.

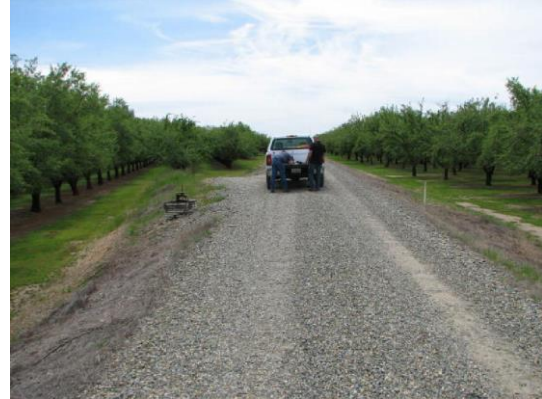
Photo 1 of 3 : UCIP_FA_2015_5397.jpg

Action/Comments					
Inspector Comments: FS_ID:46352					
DS_ID:16345					
EP_NO: N/A					
FS_HLM: 1.697					
Repair Type: Non-Urgent					
Crossing Status: Found					
UCIP Comments: 7/14/2015 4-inch pipe still present and blocking the screw gate. Crossing has 4-inch pipe inside blocking positive closure/notify landowner to remove prior to flood season. LS crossing is blocked about 50% by sediment build up. Burrow activity present on LS near crossing. 7/15/2013 Same as last inspection. 12/2/2013 Same as last inspection. 5/21/2014 Same as last inspection.					
FIELD_STRUCT_DESC: 24-inch corrugated metal irrigation pipe through the levee, 7.6 feet below the crown. Slide gate in corrugated metal pipe riser on the waterward slope. Concrete headwall on the landward side. 36-inch concrete standpipe in the channel with 2 piles to deflect debris (USACE-1960). This entry matches the Drainage or Irrigation Structure referenced in O&M manual (HLM 1.69).

Overview of levee at crossing looking downstream.

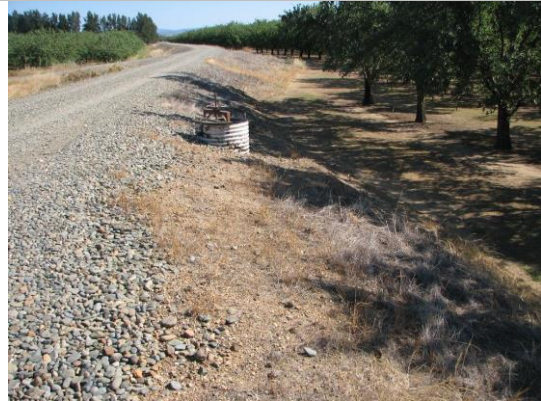
Photo 3 of 3 : UCIP_FA_2015_5399.jpg

Action/Comments					
Inspector Comments: FS_ID:46352 DS_ID:16345 EP_NO: N/A FS_HLM: 1.697 Repair Type: Non-Urgent Crossing Status: Found UCIP Comments: 7/14/2015 4-inch pipe still present and blocking the screw gate. Crossing has 4-inch pipe inside blocking positive closure/notify landowner to remove prior to flood season. LS crossing is blocked about 50% by sediment build up. Burrow activity present on LS near crossing. 7/15/2013 Same as last inspection. 12/2/2013 Same as last inspection. 5/21/2014 Same as last inspection. FIELD_STRUCT_DESC: 24-inch corrugated metal irrigation pipe through the levee, 7.6 feet below the crown. Slide gate in corrugated metal pipe riser on the waterward slope. Concrete headwall on the landward side. 36-inch concrete standpipe in the channel with 2 piles to deflect debris (USACE-1960). This entry matches the Drainage or Irrigation Structure referenced in O&M manual (HLM 1.69). FS Date: 07/23/2015

WS view looking upstream.

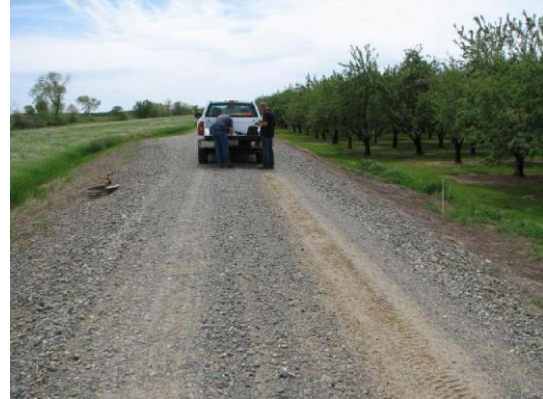
Photo 2 of 3 : UCIP_FA_2015_5401.jpg

Action/Comments					
Inspector Comments: FS_ID:46351					
DS_ID:16346					
EP_NO: N/A					
FS_HLM: 2.357					
Repair Type: Non-Urgent					
Crossing Status: Found					
UCIP Comments: 7/14/2015 Still cannot find an inlet or outelt.Non functional crossing due to LS headwall buried. This crossing was listed in the USACE Periodic Inspection report as Corp's inspect ID#USACE_CESPK_M13D_2011_p_0119 for no inlet or outlet visible.7/15/2013 Same as last inspection.12/2/2013 Same as last inspection.5/21/2014 Same as last inspection.					
FIELD_STRUCT_DESC: 24-inch corrugated metal irrigation pipe through the levee 7.8 feet below the crown. Slide gate in corrugated metal pipe riser on the waterward slope. Pipe continues across channel. Concrete "U" headwall on the landward side. (USACE-1960). This entry matches the Drainage or Irrigation Structure referenced in O&M manual (HLM 2.35).					
FS Date: 07/23/2015

Overview of crossing looking DS.

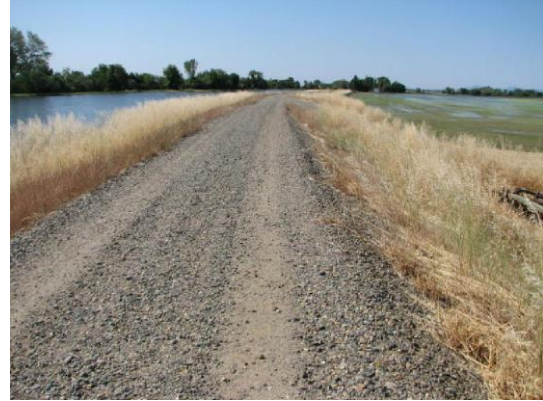
Photo 3 of 4 : UCIP_FA_2015_5535.jpg

Inspector Comments: FS_ID:46344
 DS_ID:16365
 EP_NO: N/A
 FS_HLM: 3.803
 Repair Type: Urgent
 Crossing Status: Found
 UCIP Comments: 7/14/2015 LS screw gate is still damaged and buried. Crossing is non-functional. LS slide gate covered with silt. Slide gate is bent. Crossing appears not be in use. Limited inspection on WS and LS slope due to dense vegetation. Need photos of cleared slopes. 7/15/2013 Slopes have been cleared of vegetation and are in good condition. LS screw gate is still bent and silted over. 12/2/2013 Same as last inspection. 5/21/2014 Same as last inspection.
 FIELD_STRUCT_DESC: 24-inch corrugated metal drainpipe through the levee, 7.9 feet below the crown. Flap gate on the waterward end. Screw gate on the landward end. Concrete "U" headwalls on both ends (USACE-1960). This entry matches the Drainage or Irrigation Structure referenced in O&M manual (HLM 3.82).
 FS Date: 07/23/2015

Overview of levee crown at crossing looking downstream.

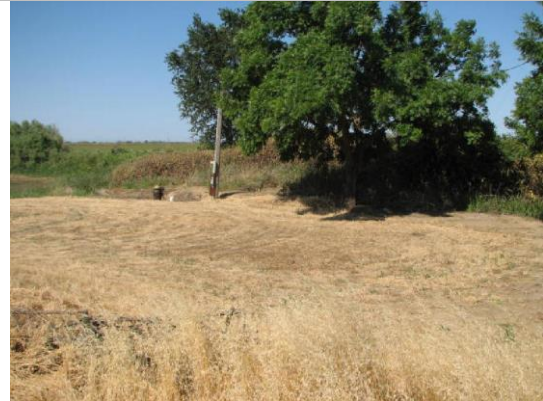
Photo 4 of 4 : UCIP_FA_2015_5536.jpg

LM Start	3.74	Rating **	U	Issue No.	51 (cont)
LM End	3.74	Issue Type +	En	Location *	LS
Category	Supplemental			GPS Latitude/Longitude	
				Start	End
Item	DWR UCIP Field Study			39.546317 °	39.546317 °
				-121.707510 °	-121.707510 °
DWR ID					
Action/Comments					
Inspector Comments: FS_ID:46344 DS_ID:16365 EP_NO: N/A FS_HLM: 3.803 Repair Type: Urgent Crossing Status: Found UCIP Comments: 7/14/2015 LS screw gate is still damaged and buried. Crossing is non-functional.LS slide gate covered with silt. Slide gate is bent. Crossing appears not be in use. Limited inspection on WS and LS slope due to dense vegetation. Need photos of cleared slopes.7/15/2013 Slopes have been cleared of vegetation and are in good condition. LS screw gate is still bent and silted over.12/2/2013 Same as last inspection.5/21/2014 Same as last inspection. FIELD_STRUCT_DESC: 24-inch corrugated metal drainpipe through the levee, 7.9 feet below the crown. Flap gate on the waterward end. Screw gate on the landward end. Concrete "U" headwalls on both ends (USACE-1960). This entry matches the Drainage or Irrigation Structure referenced in O&M manual (HLM 3.82). FS Date: 07/23/2015

View of LS toe.

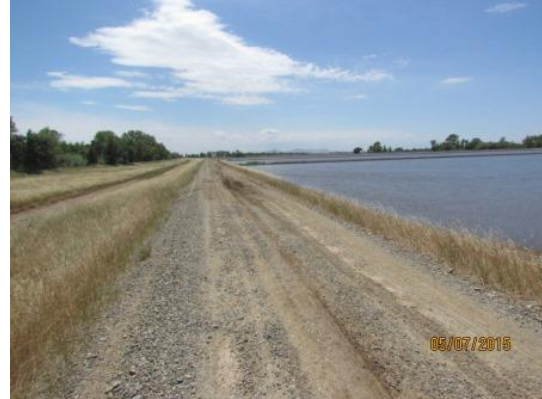
Photo 1 of 1 : FA_2015_MA0013_300_47_20150910_00013.jpg

LM Start	4.45	Rating **	M	Issue No.	47
LM End	5.35	Issue Type +	Ma	Location *	CR
Category	Earthen Levee			GPS Latitude/Longitude	
				Start	End
Item	Crown Surface / Depressions / Rutting			39.536017 °	39.523020 °
				-121.707705 °	-121.707577 °
DWR ID	DWR_MA0013_01_s_2015_47				
Action/Comments					
Repair depressions or ruts in the crown or slope.					
Inspector Comments: Repair the ruts in the crown roadway.

View of the ruts in the crown roadway.

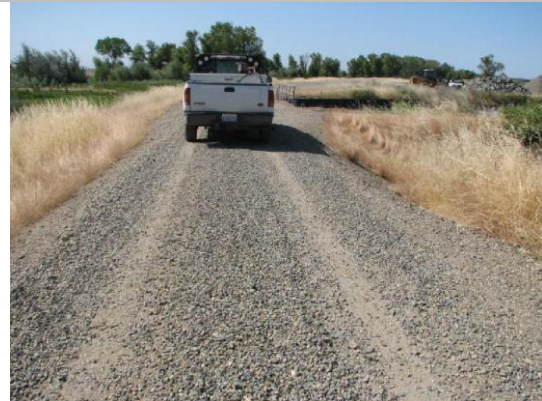
Photo 1 of 3 : UCIP_FA_2015_5566.jpg

LM Start	5.38	Rating **	M	Issue No.	52
LM End	5.38	Issue Type +	En	Location *	CR
Category	Supplemental			GPS Latitude/Longitude	
				Start	End
Item	DWR UCIP Field Study			39.522566 °	39.522566 °
				-121.707560 °	-121.707560 °
DWR ID					
Action/Comments					
Inspector Comments: FS_ID:46271					
DS_ID:16357					
EP_NO: N/A					
FS_HLM: 5.466					
Repair Type: Non-Urgent					
Crossing Status: Found					
UCIP Comments: 7/13/2015 WS flapgate is blocked from opening by sediment. Needs to be dug out.Limited inspection on WS and LS slopes due to dense vegetation. Need photos of cleared slopes.7/15/2013 Slopes have been cleared of vegetation and are in good condition.12/2/2013 Same as last inspection.5/21/2014 Same as last inspection.					
FIELD_STRUCT_DESC: 24-inch corrugated metal drainpipe through the levee, 8.6 feet below the crown. Flap gate on the waterward end. Concrete "U" headwalls an both ends (USACE-1960). This entry matches the Drainage or Irrigation Structure referenced in O&M manual (HLM 5.48).

Overview of levee crown at crossing looking downstream.

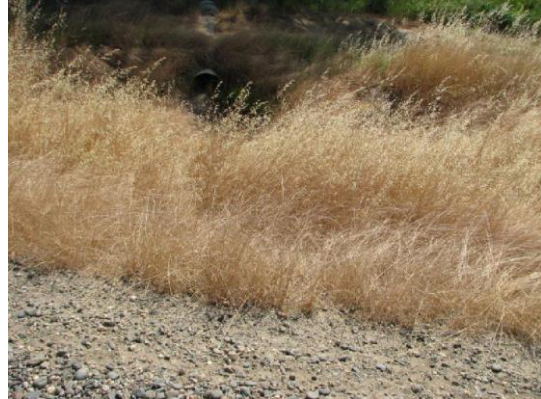
Photo 2 of 3 : UCIP_FA_2015_5567.jpg

Inspector Comments: FS_ID:46271
DS_ID:16357
EP_NO: N/A
FS_HLM: 5.466
Repair Type: Non-Urgent
Crossing Status: Found
UCIP Comments: 7/13/2015 WS flapgate is blocked from opening by sediment. Needs to be dug out. Limited inspection on WS and LS slopes due to dense vegetation. Need photos of cleared slopes. 7/15/2013 Slopes have been cleared of vegetation and are in good condition. 12/2/2013 Same as last inspection. 5/21/2014 Same as last inspection.
FIELD_STRUCT_DESC: 24-inch corrugated metal drainpipe through the levee, 8.6 feet below the crown. Flap gate on the waterward end. Concrete "U" headwalls an both ends (USACE-1960). This entry matches the Drainage or Irrigation Structure referenced in O&M manual (HLM 5.48).
FS Date: 07/17/2015

View of WS slope and channel.

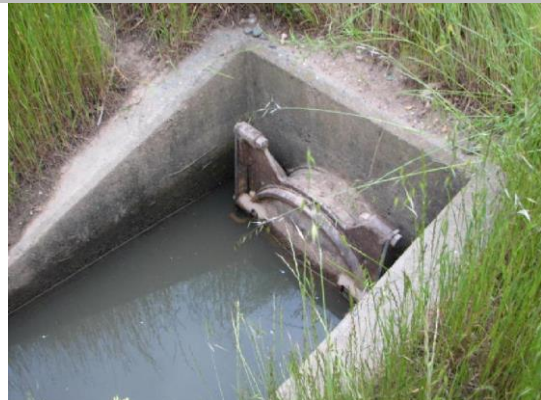
Photo 3 of 3 : UCIP_FA_2015_5568.jpg

View of WS flap gate.

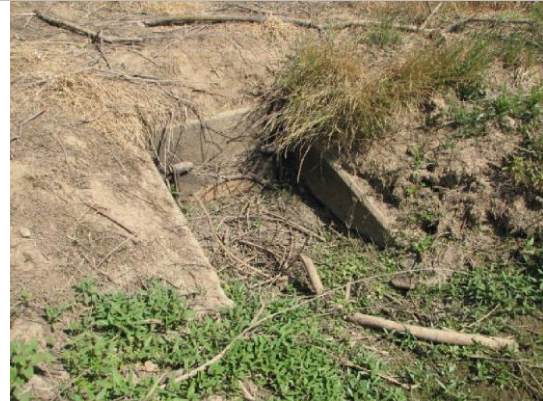
Photo 1 of 3 : UCIP_FA_2015_5627.jpg

LM Start	5.63	Rating **	U	Issue No.	53
LM End	5.63	Issue Type +	En	Location *	CR
Category	Supplemental			GPS Latitude/Longitude	
				Start	End
Item	DWR UCIP Field Study			39.519212 °	39.519212 °
				-121.709030 °	-121.709030 °
DWR ID					
Action/Comments					
Inspector Comments: FS_ID:46276					
DS_ID:16359					
EP_NO: N/A					
FS_HLM: 5.723					
Repair Type: Urgent					
Crossing Status: Found

View of WS flap gate buried.

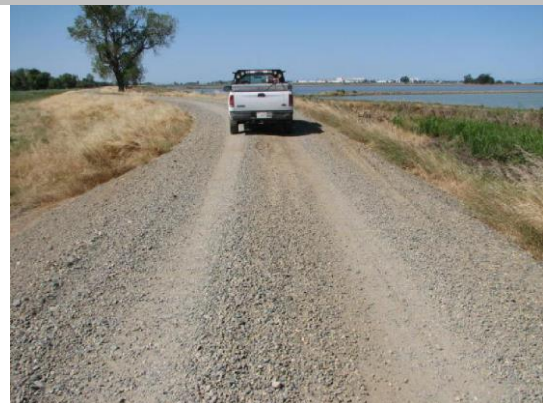
Photo 2 of 3 : UCIP_FA_2015_5628.jpg

Overview of levee crown at crossing looking downstream.

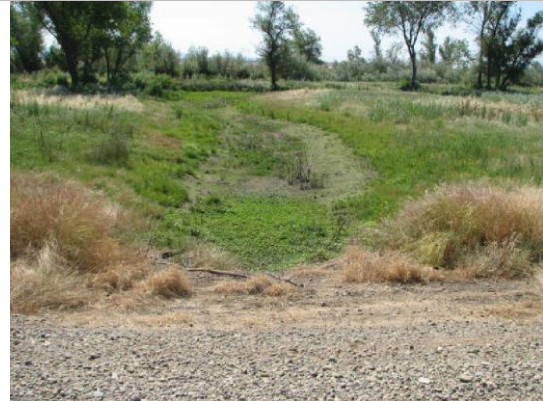
Photo 3 of 3 : UCIP_FA_2015_5629.jpg

LM Start	5.63	Rating **	U	Issue No.	53 (cont)
LM End	5.63	Issue Type +	En	Location *	CR
Category	Supplemental			GPS Latitude/Longitude	
				Start	End
Item	DWR UCIP Field Study			39.519212 °	39.519212 °
				-121.709030 °	-121.709030 °
DWR ID					
Action/Comments					
Inspector Comments: FS_ID:46276					
DS_ID:16359					
EP_NO: N/A					
FS_HLM: 5.723					
Repair Type: Urgent					
Crossing Status: Found

View of WS slope and toe.

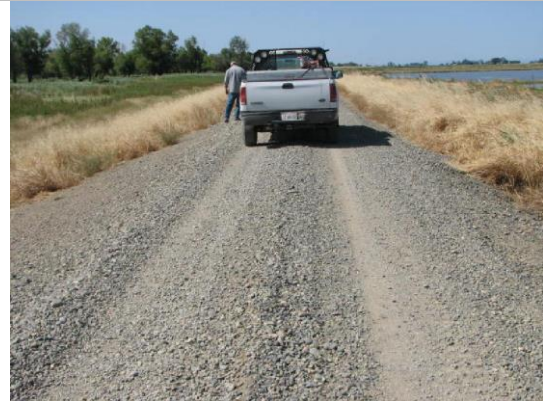
Photo 2 of 3 : UCIP_FA_2015_4389.jpg

Action/Comments					
Inspector Comments: FS_ID:46277 DS_ID:16360 EP_NO: N/A FS_HLM: 5.964 Repair Type: Non-Urgent Crossing Status: Found UCIP Comments: 7/13/2015 LS screw gate was completely submerged but crossing appears to be in good condition. Burrow activity near crossing; burrow holes present on LS. 7/15/2013 Same as last inspection. 12/2/2013 Same as last inspection. 5/21/2014 Same as last inspection. FIELD_STRUCT_DESC: 24-inch corrugated metal drainpipe through the levee, 6.2 feet below the crown. Flap gate on the waterward end. Slide gate on the landward end. Concrete "U" headwalls on both ends (USACE-1960). This entry matches the Drainage or Irrigation Structure referenced in O&M manual (HLM 5.97). FS Date: 07/17/2015

Overview of levee crown at crossing looking downstream.

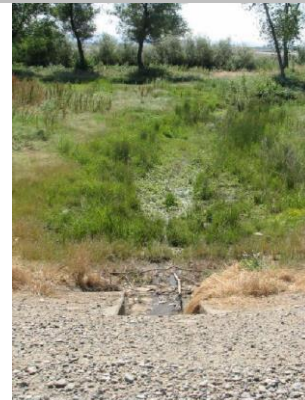
Photo 3 of 3 : UCIP_FA_2015_4390.jpg

View of WS slope and toe.

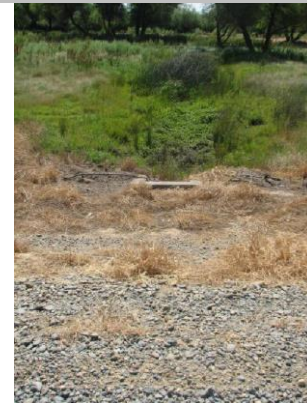
Photo 2 of 3 : UCIP_FA_2015_4392.jpg

LM Start	6.23	Rating **	U	Issue No.	55
LM End	6.23	Issue Type +	En	Location *	CR
Category	Supplemental			GPS Latitude/Longitude	
				Start	End
Item	DWR UCIP Field Study			39.511337 °	39.511337 °
				-121.713620 °	-121.713620 °
DWR ID					
Action/Comments					
Inspector Comments: FS_ID:46278					
DS_ID:16361					
EP_NO: N/A					
FS_HLM: 6.327					
Repair Type: Urgent					
Crossing Status: Found

View of WS slope and toe.

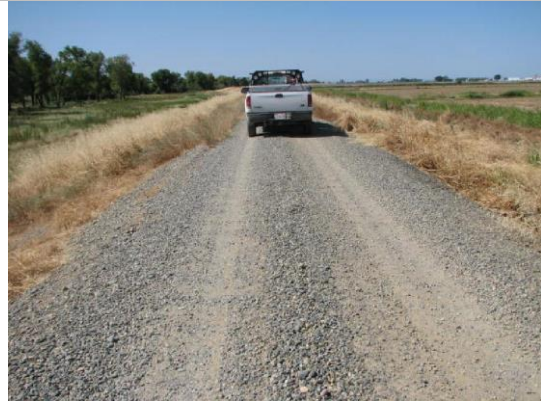
Photo 3 of 3 : UCIP_FA_2015_5645.jpg

LM Start	6.23	Rating **	U	Issue No.	55 (cont)
LM End	6.23	Issue Type +	En	Location *	CR
Category	Supplemental			GPS Latitude/Longitude	
				Start	End
Item	DWR UCIP Field Study			39.511337 °	39.511337 °
				-121.713620 °	-121.713620 °
DWR ID					
Action/Comments					
Inspector Comments: FS_ID:46278					
DS_ID:16361					
EP_NO: N/A					
FS_HLM: 6.327					
Repair Type: Urgent					
Crossing Status: Found

Overview of levee crown at crossing looking downstream.

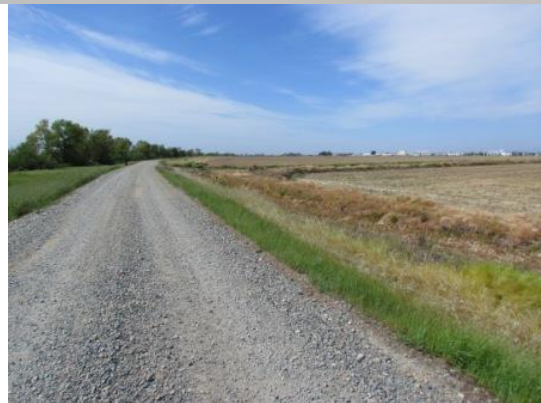
Photo 1 of 1 : FA_2015_MA0013_300_3_20150910_00002.jpg

LM Start	6.41	Rating **	M	Issue No.	3
LM End	6.99	Issue Type +	En	Location *	LS
Category	Earthen Levee			GPS Latitude/Longitude	
				Start	End
Item	Encroachments			39.508928 °	39.501438 °
				-121.714842 °	-121.719715 °
DWR ID	DWR_MA0013_01_s_2012_3				
Action/Comments					
Ditch

View of the agricultural ditch along the toe.

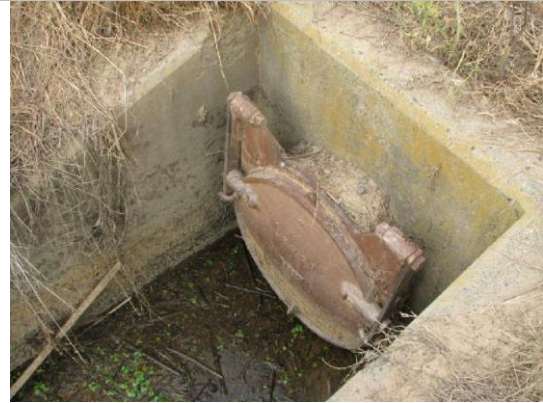
Photo 1 of 3 : UCIP_FA_2015_5646.jpg

UCIP Comments: 7/13/2015 Hole still present behind the LS flashboards. Hole behind flashboards against slide gate on LS slope (Health and Safety Issue). Limited inspection on WS slope due to dense vegetation. Need photo of cleared slope on WS. 7/15/2013 WS slope has been cleared of vegetation and is in good condition. Hole is still present behind flash boards on LS. 12/2/2013 Same as last inspection. 5/21/2014 Same as last inspection.

WS flap gate.

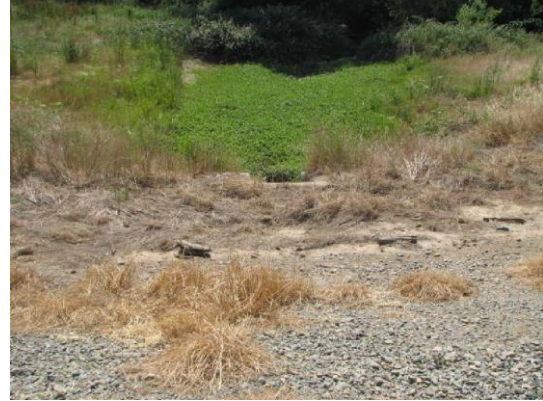
Photo 2 of 3 : UCIP_FA_2015_5647.jpg

View of WS slope and toe.

Action/Comments					
Inspector Comments: FS_ID:46279 DS_ID:16362 EP_NO: 5200B FS_HLM: 6.554 Repair Type: Urgent Crossing Status: Found UCIP Comments: 7/13/2015 Hole still present behind the LS flashboards. Hole behind flashboards against slide gate on LS slope (Health and Safety Issue). Limited inspection on WS slope due to dense vegetation. Need photo of cleared slope on WS. 7/15/2013 WS slope has been cleared of vegetation and is in good condition. Hole is still present behind flash boards on LS. 12/2/2013 Same as last inspection. 5/21/2014 Same as last inspection. FIELD_STRUCT_DESC: 1 of 10 items under Board Order 5200, 5200A, and 5200B: 24-inch corrugated metal drainpipe through the levee, 7.8 feet below the crown. Flap gate on the waterward end. Slide gate on the landward end. Concrete head wall on both ends (Board Order 5200B-1965). This entry matches the Drainage or Irrigation Structure referenced in O&M manual (HLM 6.56). FS Date: 07/17/2015

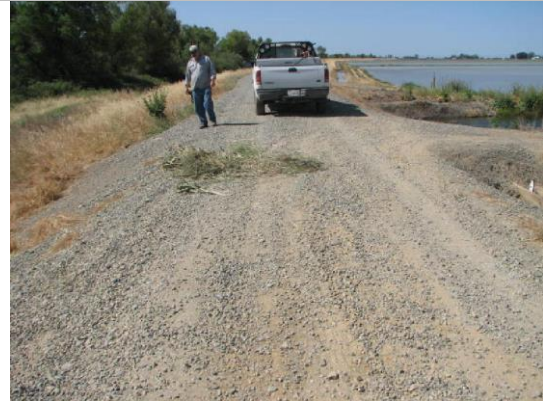
Photo 3 of 3 : UCIP_FA_2015_5648.jpg

Action/Comments					
Inspector Comments: FS_ID:46279 DS_ID:16362 EP_NO: 5200B FS_HLM: 6.554 Repair Type: Urgent Crossing Status: Found UCIP Comments: 7/13/2015 Hole still present behind the LS flashboards. Hole behind flashboards against slide gate on LS slope (Health and Safety Issue). Limited inspection on WS slope due to dense vegetation. Need photo of cleared slope on WS. 7/15/2013 WS slope has been cleared of vegetation and is in good condition. Hole is still present behind flash boards on LS. 12/2/2013 Same as last inspection. 5/21/2014 Same as last inspection. FIELD_STRUCT_DESC: 1 of 10 items under Board Order 5200, 5200A, and 5200B: 24-inch corrugated metal drainpipe through the levee, 7.8 feet below the crown. Flap gate on the waterward end. Slide gate on the landward end. Concrete head wall on both ends (Board Order 5200B-1965). This entry matches the Drainage or Irrigation Structure referenced in O&M manual (HLM 6.56). FS Date: 07/17/2015

Overview of levee crown at crossing looking downstream.

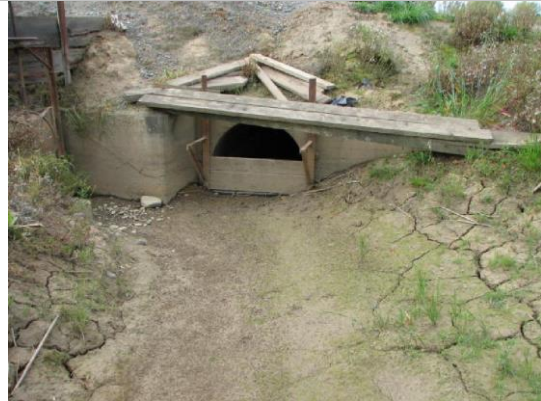
Photo 1 of 3 : UCIP_FA_2015_5649.jpg

Inspector Comments: FS_ID:46280
DS_ID:16363
EP_NO: 5200B
FS_HLM: 6.555
Repair Type: Non-Urgent
Crossing Status: Found
UCIP Comments: 7/13/2015 Same as last inspection. Clear wooden debris on upstream headwall. Upstream location latitude = 39.508298, longitude = -121.715103. Downstream location latitude = 39.50797, longitude = -121.71534; .7/15/2013 Same as last inspection. 12/2/2013 Same as last inspection. 5/21/2014 Same as last inspection.
FIELD_STRUCT_DESC: 2 of 10 items under Board Order 5200, 5200A, and 5200B: 36-inch concrete reinforced drain pipe through levee along landward shoulder, 11.1 feet below crown. Crossing saddles landward slope, open on both ends. (Board Order 5200B-1967)
FS Date: 07/17/2015

Front view of upstream headwall on LS

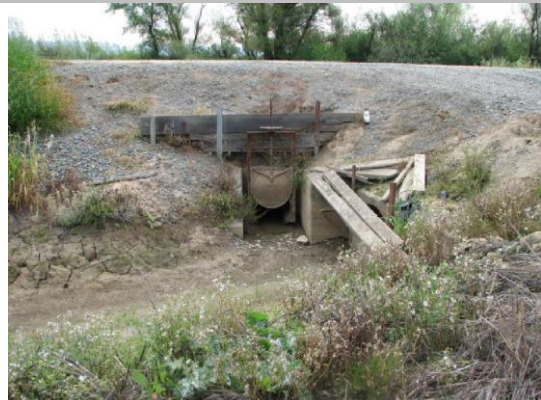
Photo 2 of 3 : UCIP_FA_2015_5650.jpg

View of crossing through ramp.

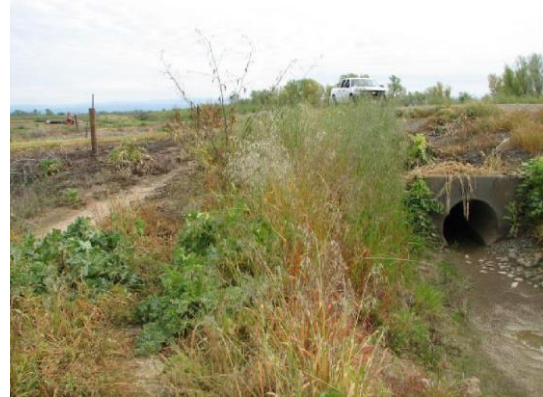
Photo 3 of 3 : UCIP_FA_2015_5651.jpg

View of crossing looking U/S at ramp.

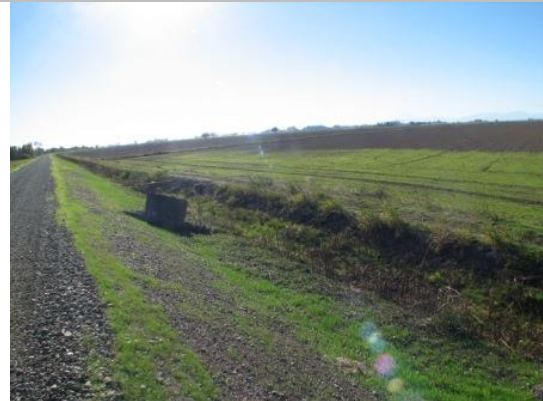
Photo 1 of 1 : FA_2015_MA0013_300_2_20150910_00001.jpg

LM Start	6.53	Rating **	M	Issue No.	2
LM End	6.53	Issue Type +	Ma	Location *	LS
Category	Earthen Levee			GPS Latitude/Longitude	
				Start	End
Item	Encroachments			39.507337 °	39.507337 °
				-121.715693 °	-121.715693 °
DWR ID	DWR_MA0013_01_s_2012_2				
Action/Comments					
Material

View of a concrete block along the toe.

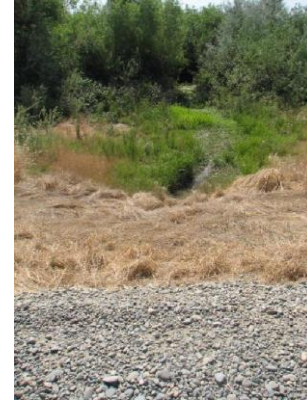
Photo 1 of 3 : UCIP_FA_2015_5762.jpg

View of WS slope and toe.

Action/Comments					
Inspector Comments: FS_ID:46286 DS_ID:16329 EP_NO: N/A FS_HLM: 7.094 Repair Type: Urgent Crossing Status: Found UCIP Comments: 7/13/2015 LS screw gate needs to be replaced. Everything else with crossing seems to be in good condition. LMA's inspection sheet of 2011 indicates settlement and visible corrosion. Damage/severe corrosion on screw gate where it bolts to headwall. No visible signs of settlement due to high vegetation cover. Limited inspection on WS and LS slopes due to dense vegetation. Need photos of cleared slopes for this crossing. 7/15/2013 Slopes have been cleared of vegetation and are in good condition. There were no apparent signs of settling. LS screw gate is still damaged. 12/2/2013 Same as last inspection. 5/21/2014 Same as last inspection. FIELD_STRUCT_DESC: 24-inch corrugated metal drainpipe through the levee, 9.8 feet below the crown. Flap gate on the waterward end. Slide gate on the landward end. Concrete headwall on both ends (USACE-1960). This entry matches the Drainage or Irrigation Structure referenced in O&M manual (HLM 7.10). FS Date: 07/17/2015

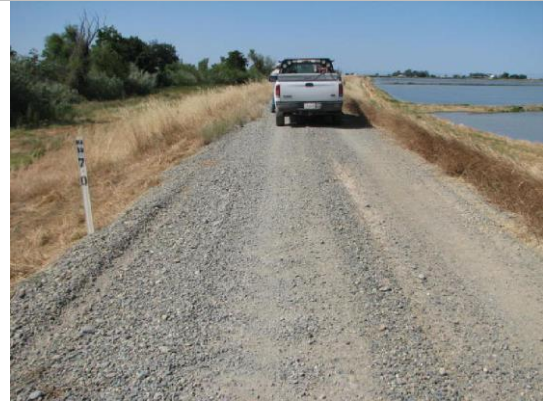
Photo 2 of 3 : UCIP_FA_2015_5763.jpg

Overview of levee crown at crossing looking D/S.

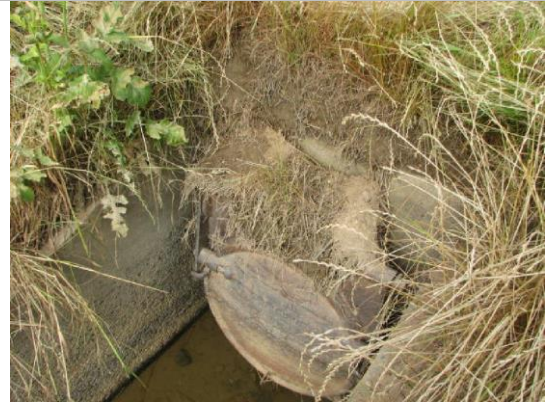
Photo 3 of 3 : UCIP_FA_2015_5764.jpg

WS Flap Gate

Action/Comments					
Inspector Comments: FS_ID:46286 DS_ID:16329 EP_NO: N/A FS_HLM: 7.094 Repair Type: Urgent Crossing Status: Found UCIP Comments: 7/13/2015 LS screw gate needs to be replaced. Everything else with crossing seems to be in good condition. LMA's inspection sheet of 2011 indicates settlement and visible corrosion. Damage/severe corrosion on screw gate where it bolts to headwall. No visible signs of settlement due to high vegetation cover. Limited inspection on WS and LS slopes due to dense vegetation. Need photos of cleared slopes for this crossing. 7/15/2013 Slopes have been cleared of vegetation and are in good condition. There were no apparent signs of settling. LS screw gate is still damaged. 12/2/2013 Same as last inspection. 5/21/2014 Same as last inspection. FIELD_STRUCT_DESC: 24-inch corrugated metal drainpipe through the levee, 9.8 feet below the crown. Flap gate on the waterward end. Slide gate on the landward end. Concrete headwall on both ends (USACE-1960). This entry matches the Drainage or Irrigation Structure referenced in O&M manual (HLM 7.10). FS Date: 07/17/2015

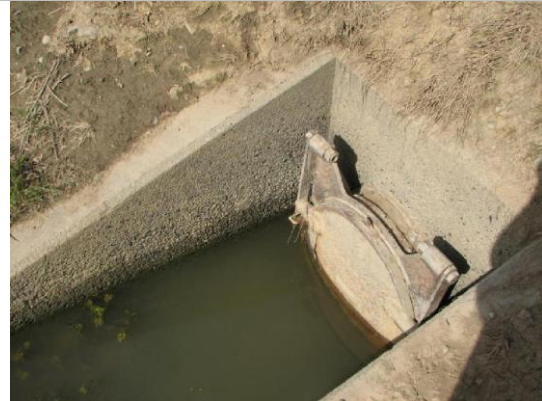
Photo 1 of 3 : UCIP_FA_2015_5765.jpg

Inspector Comments: FS_ID:46287
 DS_ID:16354
 EP_NO: N/A
 FS_HLM: 7.33
 Repair Type: Urgent
 Crossing Status: Found
 UCIP Comments: 7/13/2015 LS screw gate stem is still bent. Gate should still be able to close fully. The rest of the crossing seems to be in good condition. LS slide gate stem is bent and needs to be replaced. Limited inspection on WS and LS slope due to dense vegetation. Need photos of cleared slopes during next inspection. Confirmed flap gate on WS. This crossing was listed in the USACE Periodic Inspection report as Corp's inspect
 ID#USACE_CESPK_M13D_2011_p_0244 for submerged WS gate. 7/15/2013 Slopes have been cleared of vegetation and are in good condition. LS screw gate stem is still bent. 12/2/2013 Same as last inspection. 5/21/2014 Same as last inspection.
 FIELD_STRUCT_DESC: 24-inch corrugated metal drainpipe through the levee, 11.2 feet below the crown. Flap gate on the waterward end. Slide gate on the landward end. Concrete "U" headwall on both ends (USACE-1960). This entry matches the Drainage or Irrigation Structure referenced in O&M manual (HLM 7.34).

WS Flap Gate

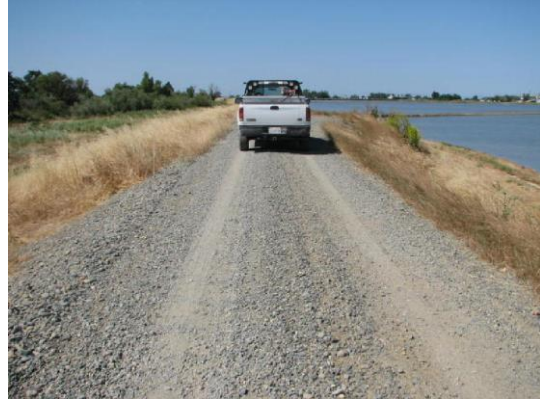
Photo 2 of 3 : UCIP_FA_2015_5766.jpg

Overview of levee crown at crossing looking D/S.

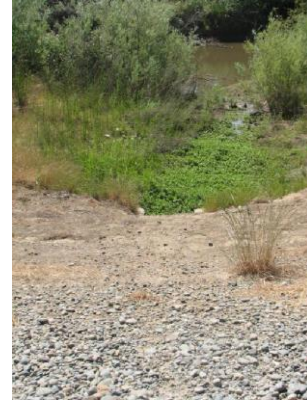
Photo 3 of 3 : UCIP_FA_2015_5767.jpg

View of WS slope and toe.

Action/Comments					
Inspector Comments: FS_ID:46287 DS_ID:16354 EP_NO: N/A FS_HLM: 7.33 Repair Type: Urgent Crossing Status: Found UCIP Comments: 7/13/2015 LS screw gate stem is still bent. Gate should still be able to close fully. The rest of the crossing seems to be in good condition. LS slide gate stem is bent and needs to be replaced. Limited inspection on WS and LS slope due to dense vegetation. Need photos of cleared slopes during next inspection. Confirmed flap gate on WS. This crossing was listed in the USACE Periodic Inspection report as Corp's inspect ID#USACE_CESPK_M13D_2011_p_0244 for submerged WS gate. 7/15/2013 Slopes have been cleared of vegetation and are in good condition. LS screw gate stem is still bent. 12/2/2013 Same as last inspection. 5/21/2014 Same as last inspection. FIELD_STRUCT_DESC: 24-inch corrugated metal drainpipe through the levee, 11.2 feet below the crown. Flap gate on the waterward end. Slide gate on the landward end. Concrete "U" headwall on both ends (USACE-1960). This entry matches the Drainage or Irrigation Structure referenced in O&M manual (HLM 7.34). FS Date: 07/17/2015

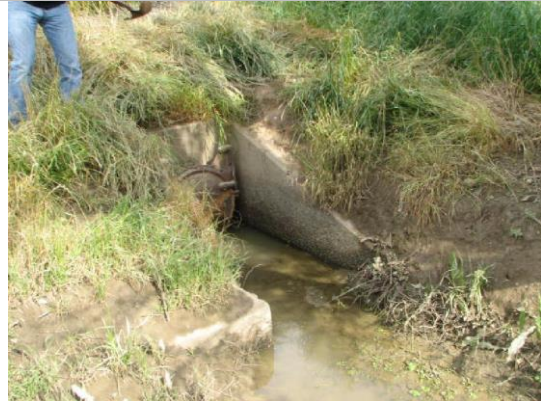
Photo 1 of 3 : UCIP_FA_2015_5292.jpg

UCIP Comments: 7/13/2015 WS ditch is getting to be heavily vegetated but it is not yet affecting flap gate operation. Vegetation needs to be cleared back some. Limited inspection on WS and LS slopes due to dense vegetation. Need photos of cleared WS and LS slopes during next inspection. 7/15/2013 Slopes have been cleared of vegetation and are in good condition. 12/2/2013 Same as last inspection. 5/21/2014 Same as last inspection.

View of WS flap gate. Dense vegetation on WS slope.

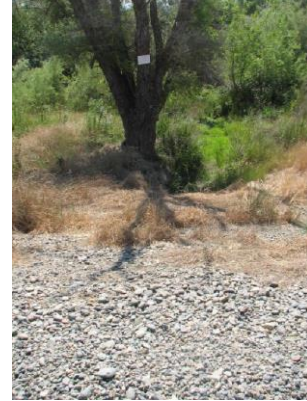
Photo 2 of 3 : UCIP_FA_2015_5293.jpg

WS view of slope and channel.

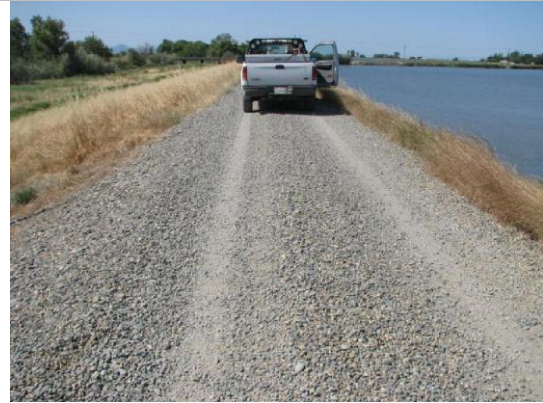
Photo 3 of 3 : UCIP_FA_2015_5294.jpg

View of levee crown at crossing looking D/S.

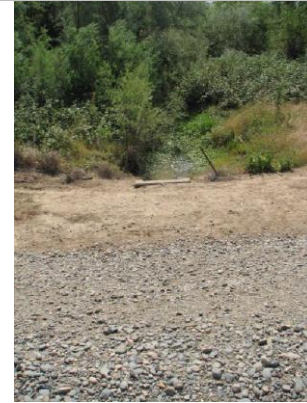
Photo 1 of 3 : UCIP_FA_2015_5441.jpg

Inspector Comments: FS_ID:46293
 DS_ID:16322
 EP_NO: N/A
 FS_HLM: 8.397
 Repair Type: Non-Urgent
 Crossing Status: Found
 UCIP Comments: 7/13/2015 Minor sediment build up blocking flap gate from opening on WS. Needs to be dug out. Sediment build up on LS. Debris (broken panels) scattered near LS headwall. Limited inspection on WS and LS slope due to dense vegetation. Need photos of cleared WS and LS slopes. 7/15/2013 Slopes are cleared of vegetation and are in good condition. WS flapgate is blocked from opening fully by sediment. 12/3/2013 Same as last inspection. 5/21/2014 Same as last inspection.
 FIELD_STRUCT_DESC: 24-inch corrugated metal drainpipe through the levee, 9.3 feet below the crown. Flap gate on the waterward end. Concrete "U" headwalls on both ends (USACE-1960). Flashboards should be present on the landward side. This entry matches the Drainage or Irrigation Structure referenced in O&M manual (HLM 8.40).

View of WS slope and toe.

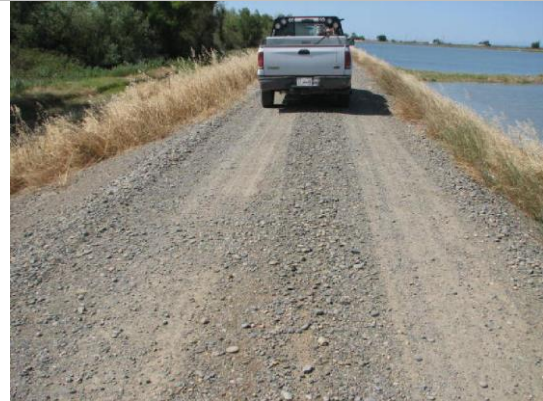
Photo 2 of 3 : UCIP_FA_2015_5442.jpg

Overview of levee crown at crossing looking D/S.

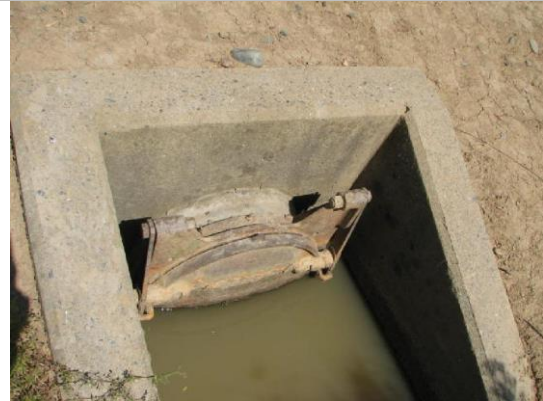
Photo 3 of 3 : UCIP_FA_2015_5443.jpg

Action/Comments					
Inspector Comments: FS_ID:46293 DS_ID:16322 EP_NO: N/A FS_HLM: 8.397 Repair Type: Non-Urgent Crossing Status: Found UCIP Comments: 7/13/2015 Minor sediment build up blocking flap gate from opening on WS. Needs to be dug out.Sediment build up on LS. Debris (broken panels) scattered near LS headwall. Limited inspection on WS and LS slope due to dense vegetation. Need photos of cleared WS and LS slopes.7/15/2013 Slopes are cleared of vegetation and are in good condition. WS flapgate is blocked from opening fully by sediment.12/3/2013 Same as last inspection.5/21/2014 Same as last inspection. FIELD_STRUCT_DESC: 24-inch corrugated metal drainpipe through the levee, 9.3 feet below the crown. Flap gate on the waterward end. Concrete "U" headwalls on both ends (USACE-1960). Flashboards should be present on the landward side. This entry matches the Drainage or Irrigation Structure referenced in O&M manual (HLM 8.40). FS Date: 07/17/2015

View of WS flap gate and headwall.

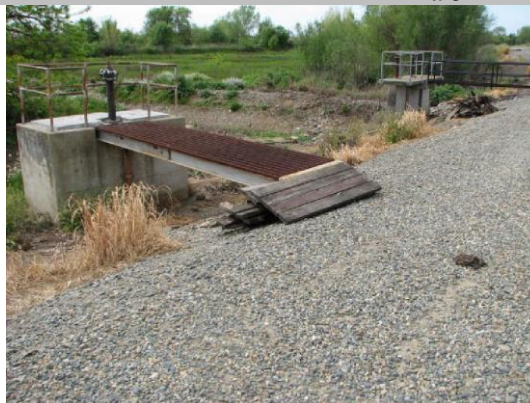
Photo 1 of 3 : UCIP_FA_2015_4939.jpg

Action/Comments					
Inspector Comments: FS_ID:46328 DS_ID:16323 EP_NO: N/A FS_HLM: 8.952 Repair Type: Urgent Crossing Status: Found UCIP Comments: 7/13/2015 Erosion still present behind the LS headwall. It looks to be getting worse and is starting to affect the levee slope. Concrete headwall is cracked, erosion behind headwall is also present. LS headwall needs to be repaired/replaced. Remove wooden debris from levee shoulder. 7/15/2013 Same as last inspection. 12/3/2013 Same as last inspection. 5/21/2014 Same as last inspection. FIELD_STRUCT_DESC: Richvale Irrigation Canal siphon crosses the channel. Five (5) by seven (7) foot concrete conduit through the levee, 18.4 feet below the crown. Distribution box and walkway are located on waterward side. Concrete headwall on the landward side. 28-foot reinforced concrete protective slab on top of the conduit in the center of the levee (USACE-1960). This entry matches the Drainage or Irrigation Structure referenced in O&M manual (HLM 8.95). FS Date: 07/21/2015

Catwalk and screw gate located on WS.

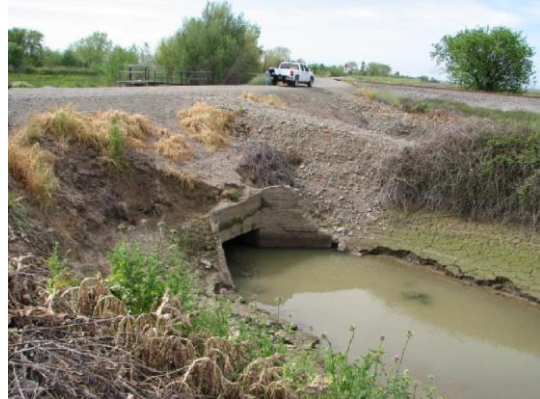
Photo 2 of 3 : UCIP_FA_2015_4940.jpg

Action/Comments					
Inspector Comments: FS_ID:46328 DS_ID:16323 EP_NO: N/A FS_HLM: 8.952 Repair Type: Urgent Crossing Status: Found UCIP Comments: 7/13/2015 Erosion still present behind the LS headwall. It looks to be getting worse and is starting to affect the levee slope. Concrete headwall is cracked, erosion behind headwall is also present. LS headwall needs to be repaired/replaced. Remove wooden debris from levee shoulder. 7/15/2013 Same as last inspection. 12/3/2013 Same as last inspection. 5/21/2014 Same as last inspection. FIELD_STRUCT_DESC: Richvale Irrigation Canal siphon crosses the channel. Five (5) by seven (7) foot concrete conduit through the levee, 18.4 feet below the crown. Distribution box and walkway are located on waterward side. Concrete headwall on the landward side. 28-foot reinforced concrete protective slab on top of the conduit in the center of the levee (USACE-1960). This entry matches the Drainage or Irrigation Structure referenced in O&M manual (HLM 8.95). FS Date: 07/21/2015

View of LS structure. Erosion present behind headwall.

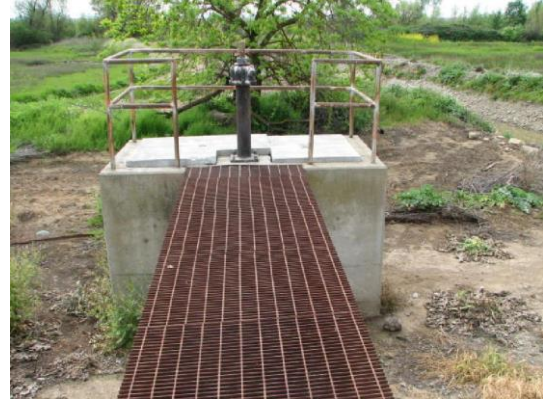
Photo 3 of 3 : UCIP_FA_2015_4941.jpg

Inspector Comments: FS_ID:46328
DS_ID:16323
EP_NO: N/A
FS_HLM: 8.952
Repair Type: Urgent
Crossing Status: Found
UCIP Comments: 7/13/2015 Erosion still present behind the LS headwall. It looks to be getting worse and is starting to affect the levee slope. Concrete headwall is cracked, erosion behind headwall is also present. LS headwall needs to be repaired/replaced. Remove wooden debris from levee shoulder. 7/15/2013 Same as last inspection. 12/3/2013 Same as last inspection. 5/21/2014 Same as last inspection.
FIELD_STRUCT_DESC: Richvale Irrigation Canal siphon crosses the channel. Five (5) by seven (7) foot concrete conduit through the levee, 18.4 feet below the crown. Distribution box and walkway are located on waterward side. Concrete headwall on the landward side. 28-foot reinforced concrete protective slab on top of the conduit in the center of the levee (USACE-1960). This entry matches the Drainage or Irrigation Structure referenced in O&M manual (HLM 8.95).

Catwalk & gate located on WS. No daylight point on WS.

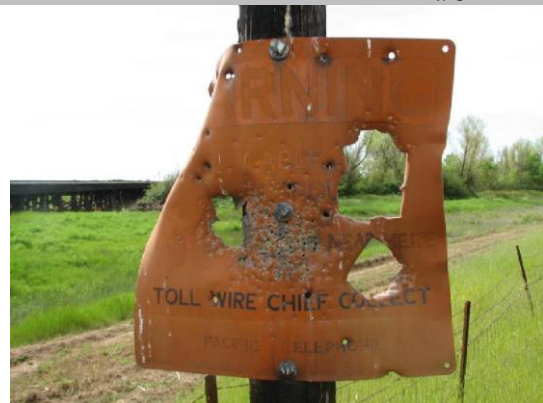
Photo 1 of 1 : UCIP_FA_2015_3195.jpg

Inspector Comments: FS_ID:46300
DS_ID:16328
EP_NO: 1234A
FS_HLM: 9.03
Repair Type: Non-Urgent
Crossing Status: Indicator Found
UCIP Comments: 7/13/2015 Crossing appears in good condition. No noticeable issues to report. Need to contact owner to replace marker. 7/15/2013 Same as last inspection. 12/3/2013 Same as last inspection. 5/21/2014 Same as last inspection.
FIELD_STRUCT_DESC: Underground telephone cable through the levee. Depth unknown. (Permit No. 1234-1947)
FS Date: 07/17/2015

Underground telephone cable marker located on WS.

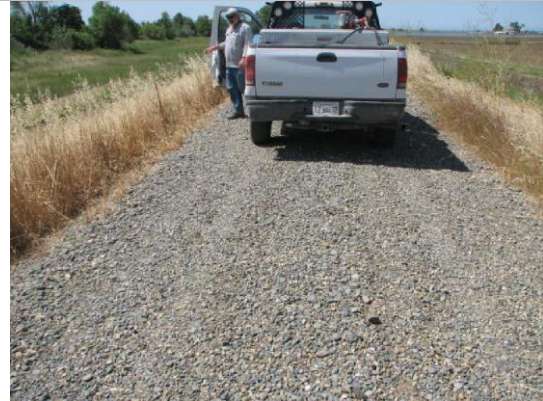
Photo 1 of 3 : UCIP_FA_2015_3196.jpg

Action/Comments					
Inspector Comments: FS_ID:46301 DS_ID:16317 EP_NO: N/A FS_HLM: 9.085 Repair Type: Non-Urgent Crossing Status: Found UCIP Comments: 7/13/2015 LS inlet has minor vegetation still. WS appears in good condition. Limited inspection on WS and LS slopes due to dense vegetation. Need photos of cleared WS and LS slopes. This crossing was listed in the USACE Periodic Inspections as Corp's Inpect ID# USACE_CESPK_M13D_2011_p_0278 for WS outlet sedimentation and sediment/grass at LS inlet. 7/15/2013 Slopes have been cleared of vegetation and are in good condition. 12/3/2013 Same as last inspection. 5/21/2014 Same as last inspection. FIELD_STRUCT_DESC: 36-inch corrugated metal drainpipe through the levee, 10.2 feet below the crown. Flap gate on the waterward end. Concrete "U" headwalls on both ends (USACE-1960). Flashboards should be present on the landward side. This entry matches the Drainage or Irrigation Structure referenced in O&M manual (HLM 9.09). FS Date: 07/17/2015

Overview of levee crown at crossing looking downstream.

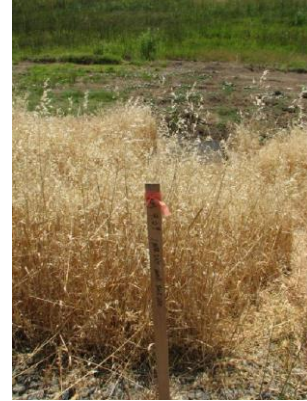
Photo 2 of 3 : UCIP_FA_2015_3197.jpg

Inspector Comments: FS_ID:46301
 DS_ID:16317
 EP_NO: N/A
 FS_HLM: 9.085
 Repair Type: Non-Urgent
 Crossing Status: Found
 UCIP Comments: 7/13/2015 LS inlet has minor vegetation still. WS appears in good condition. Limited inspection on WS and LS slopes due to dense vegetation. Need photos of cleared WS and LS slopes. This crossing was listed in the USACE Periodic Inspections as Corp's Inpect ID# USACE_CESPK_M13D_2011_p_0278 for WS outlet sedimentation and sediment/grass at LS inlet. 7/15/2013 Slopes have been cleared of vegetation and are in good condition. 12/3/2013 Same as last inspection. 5/21/2014 Same as last inspection.
 FIELD_STRUCT_DESC: 36-inch corrugated metal drainpipe through the levee, 10.2 feet below the crown. Flap gate on the waterward end. Concrete "U" headwalls on both ends (USACE-1960). Flashboards should be present on the landward side. This entry matches the Drainage or Irrigation Structure referenced in O&M manual (HLM 9.09).

View of WS slope and toe.

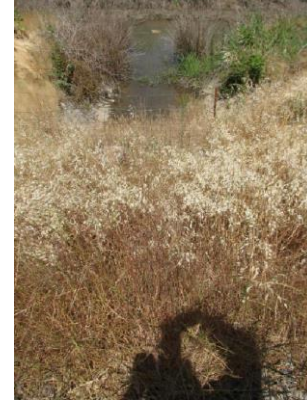
Photo 3 of 3 : UCIP_FA_2015_3198.jpg

Action/Comments					
Inspector Comments: FS_ID:46301 DS_ID:16317 EP_NO: N/A FS_HLM: 9.085 Repair Type: Non-Urgent Crossing Status: Found UCIP Comments: 7/13/2015 LS inlet has minor vegetation still. WS appears in good condition. Limited inspection on WS and LS slopes due to dense vegetation. Need photos of cleared WS and LS slopes. This crossing was listed in the USACE Periodic Inspections as Corp's Inpect ID# USACE_CESPK_M13D_2011_p_0278 for WS outlet sedimentation and sediment/grass at LS inlet. 7/15/2013 Slopes have been cleared of vegetation and are in good condition. 12/3/2013 Same as last inspection. 5/21/2014 Same as last inspection. FIELD_STRUCT_DESC: 36-inch corrugated metal drainpipe through the levee, 10.2 feet below the crown. Flap gate on the waterward end. Concrete "U" headwalls on both ends (USACE-1960). Flashboards should be present on the landward side. This entry matches the Drainage or Irrigation Structure referenced in O&M manual (HLM 9.09). FS Date: 07/17/2015

View of LS slope and toe.

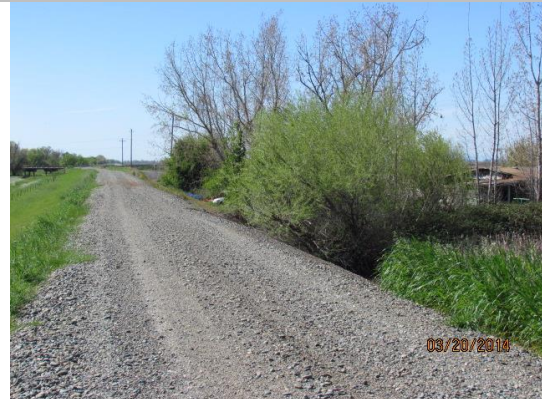
Photo 1 of 1 : FA_2015_MA0013_300_5_20150910_00003.jpg

LM Start	9.70	Rating **	M	Issue No.	5
LM End	9.72	Issue Type +	Ma	Location *	LS
Category	Earthen Levee			GPS Latitude/Longitude	
				Start	End
Item	Trim / Thin Trees			39.467170 °	39.466860 °
				-121.743887 °	-121.744108 °
DWR ID	DWR_MA0013_01_s_2012_5

Action/Comments					
Trim trees to at least five feet above ground level.

Trim the trees along the landside slope and toe.

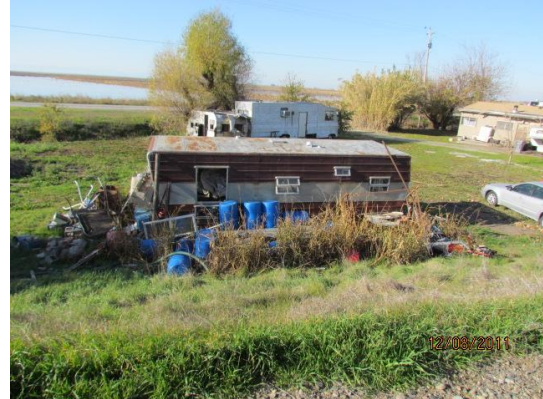
Photo 1 of 1 : FA_2015_MA0013_300_10_20150910_00005.jpg

LM Start	9.74	Rating **	M	Issue No.	10
LM End	9.74	Issue Type +	En	Location *	LS
Category	Earthen Levee			GPS Latitude/Longitude	
				Start	End
Item	Encroachments			39.466635 °	39.466635 °
				-121.744228 °	-121.744228 °
DWR ID	DWR_MA0013_01_f_2013_10				
Action/Comments					
Material Inspector Comments: Move the trailer and materials outside the 10 foot easement.

View of a trailer & material along the L/S toe.

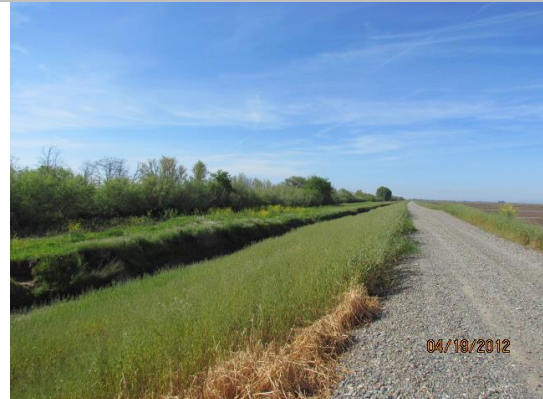
Photo 1 of 1 : FA_2015_MA0013_300_17_20150910_00007.jpg

LM Start	11.04	Rating **	M	Issue No.	17
LM End	13.28	Issue Type +	En	Location *	WS
Category	Earthen Levee			GPS Latitude/Longitude	
				Start	End
Item	Encroachments			39.449777 °	39.421255 °
				-121.755103 °	-121.774893 °
DWR ID	DWR_MA0013_01_s_2012_17				
Action/Comments					
Ditch

View of the agricultural ditch along the toe of the levee.

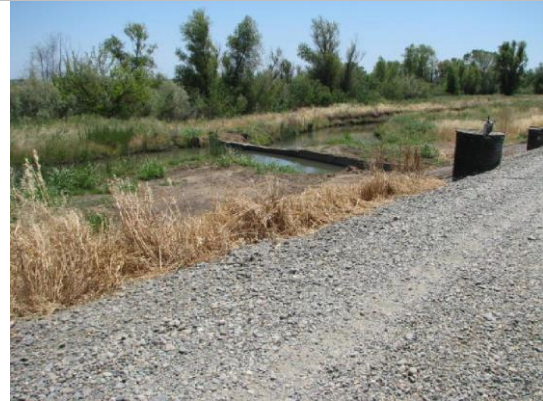
Photo 1 of 3 : UCIP_FA_2015_5104.jpg

Action/Comments					
Inspector Comments: FS_ID:46308					
DS_ID:16334					
EP_NO: N/A					
FS_HLM: 12.364					
Repair Type: Non-Urgent					
Crossing Status: Found					
UCIP Comments: 7/13/2015 New screw gate installed inside the WS standpipe. Limited inspection on WS and LS slope due to dense vegetation. WS outlet of pipe not found. Need photos of cleared WS and LS slopes. Determine if WS outlet daylight after WS slope is cleared. 7/15/2013 Slopes have been cleared of vegetation and are in good condition. Still no sign of WS end of pipe. 12/3/2013 Same as last inspection. 5/21/2014 Same as last inspection.					
FIELD_STRUCT_DESC: 30-inch corrugated metal pipe through the levee, 11.0 feet below the crown. Slide gate in corrugated metal pipe riser on the waterward slope. Concrete "U" headwall on the landward side. (USACE-1960). This entry matches the Drainage or Irrigation Structure referenced in O&M manual (HLM 12.38).

View of Ws slope and channel.

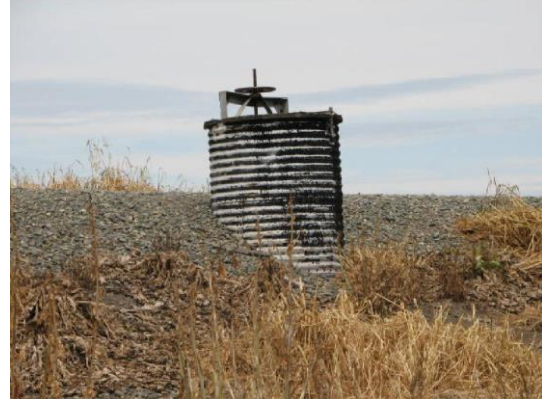
Photo 2 of 3 : UCIP_FA_2015_5149.jpg

Inspector Comments: FS_ID:46308
 DS_ID:16334
 EP_NO: N/A
 FS_HLM: 12.364
 Repair Type: Non-Urgent
 Crossing Status: Found
 UCIP Comments: 7/13/2015 New screw gate installed inside the WS standpipe. Limited inspection on WS and LS slope due to dense vegetation. WS outlet of pipe not found. Need photos of cleared WS and LS slopes. Determine if WS outlet daylighted after WS slope is cleared. 7/15/2013 Slopes have been cleared of vegetation and are in good condition. Still no sign of WS end of pipe. 12/3/2013 Same as last inspection. 5/21/2014 Same as last inspection.
 FIELD_STRUCT_DESC: 30-inch corrugated metal pipe through the levee, 11.0 feet below the crown. Slide gate in corrugated metal pipe riser on the waterward slope. Concrete "U" headwall on the landward side. (USACE-1960). This entry matches the Drainage or Irrigation Structure referenced in O&M manual (HLM 12.38).
 FS Date: 07/17/2015

Slide gate located on WS slope.

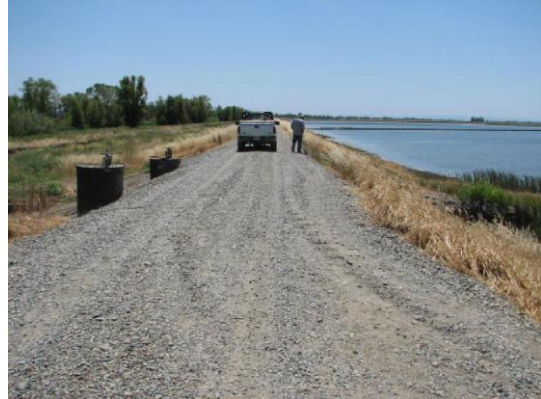
Photo 3 of 3 : UCIP_FA_2015_5150.jpg

Item	DWR UCIP Field Study			39.435169 °	39.435169 °	
				-121.765290 °	-121.765290 °	
DWR ID						
Action/Comments						
Inspector Comments: FS_ID:46308 DS_ID:16334 EP_NO: N/A FS_HLM: 12.364 Repair Type: Non-Urgent Crossing Status: Found UCIP Comments: 7/13/2015 New screw gate installed inside the WS standpipe. Limited inspection on WS and LS slope due to dense vegetation. WS outlet of pipe not found. Need photos of cleared WS and LS slopes. Determine if WS outlet daylights after WS slope is cleared.7/15/2013 Slopes have been cleared of vegetation and are in good condition. Still no sign of WS end of pipe.12/3/2013 Same as last inspection.5/21/2014 Same as last inspection. FIELD_STRUCT_DESC: 30-inch corrugated metal pipe through the levee, 11.0 feet below the crown. Slide gate in corrugated metal pipe riser on the waterward slope. Concrete "U" headwall on the landward side. (USACE-1960). This entry matches the Drainage or Irrigation Structure referenced in O&M manual (HLM 12.38). FS Date: 07/17/2015

Overview of levee crown at crossing looking downstream.

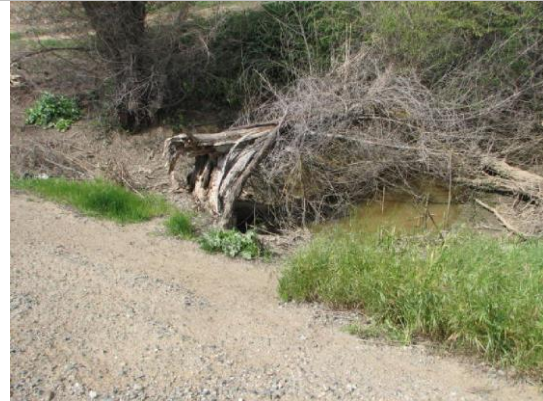
Photo 1 of 3 : UCIP_FA_2015_5264.jpg

LM Start	13.76	Rating **	U	Issue No.	67
LM End	13.76	Issue Type +	En	Location *	WS
Category	Supplemental			GPS Latitude/Longitude	
				Start	End
Item	DWR UCIP Field Study			39.416833 °	39.416833 °
				-121.781930 °	-121.781930 °
DWR ID					
Action/Comments					
Inspector Comments: FS_ID:46313					
DS_ID:16338					
EP_NO: N/A					
FS_HLM: 13.959					
Repair Type: Urgent					
Crossing Status: Found					
UCIP Comments: 7/13/2015 WS flap gate is blocked from opening by sediment and vegetation. Needs to be cleared away. LS opening is being over grown by a tree and needs to be cutback.Tree has fallen at LS inlet and damaged slide gate. The tree needs to be removed and screw gate repaired. Limited inspection on LS due to fallen tree.7/15/2013 Same as last inspection.12/3/2013 Same as last inspection.5/22/2014 Same as last inspection.					
FIELD_STRUCT_DESC: 24-inch corrugated metal drainpipe through the levee, 12.7 feet below the crown. Flap gate on the waterward side. Concrete "U" headwall on both ends (USACE-1960).

Tree fallen at LS headwall.

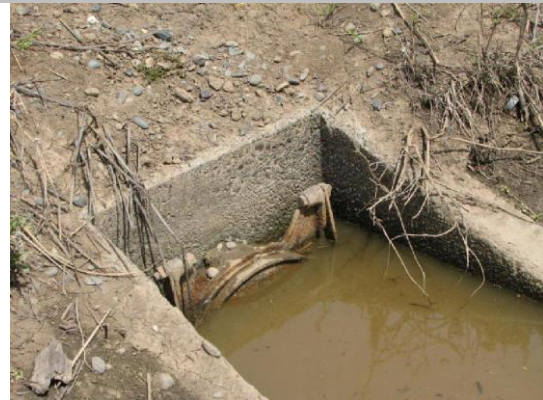
Photo 2 of 3 : UCIP_FA_2015_5265.jpg

WS headwall and flap gate.

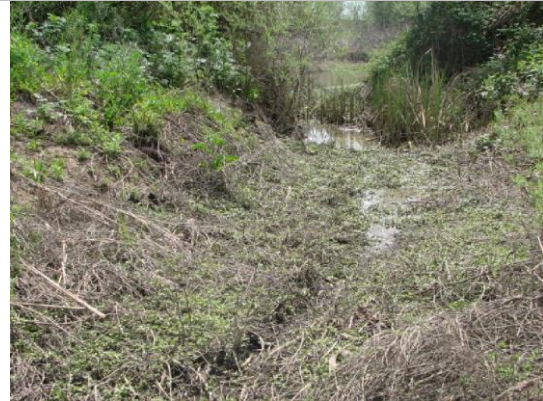
Photo 3 of 3 : UCIP_FA_2015_5266.jpg

LM Start	13.76	Rating **	U	Issue No.	67 (cont)
LM End	13.76	Issue Type +	En	Location *	WS
Category	Supplemental			GPS Latitude/Longitude	
				Start	End
Item	DWR UCIP Field Study			39.416833 °	39.416833 °
				-121.781930 °	-121.781930 °
DWR ID					
Action/Comments					
Inspector Comments: FS_ID:46313					
DS_ID:16338					
EP_NO: N/A					
FS_HLM: 13.959					
Repair Type: Urgent					
Crossing Status: Found

View of channel at crossing.
